APOLLO, COLUMBIA & CHALLENGER CASE STUDIES

Apollo 13 Launched April 11, 1970

Challenger, STS-51L Launched January 28,1986

Columbia, STS-107 Launched January 16, 2003: Deorbited February 1, 2003

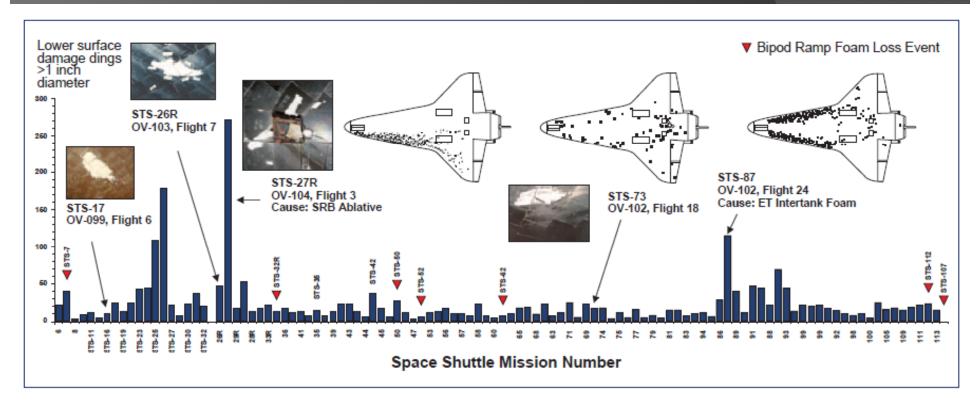
Figure 6.1-6. This chart shows the number of dings greater than one inch in diameter on the lower surface of the Orbiter after each mission from STS-6 through STS-113. Flights where the bipod ramp foam is known to have come off are marked with a red triangle.

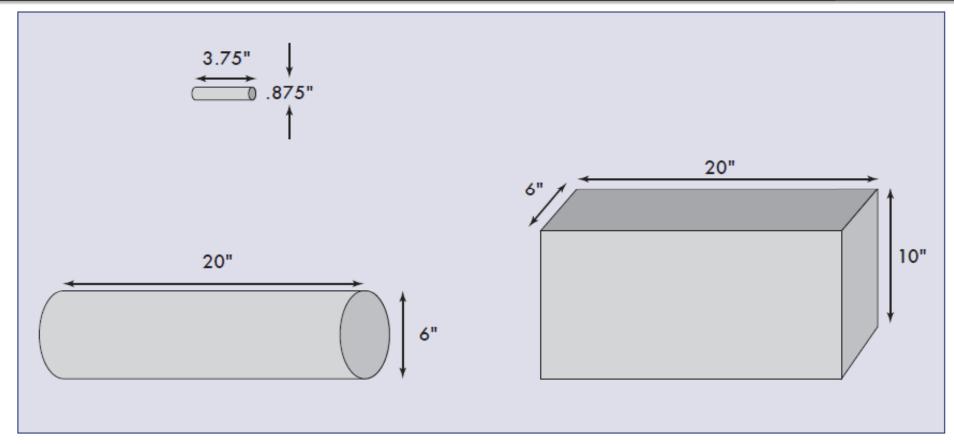
Figure 6.3-1. The small cylinder at top illustrates the size of debris Crater was intended to analyze. The larger cylinder was used for the STS-107 analysis; the block at right is the estimated size of the foam.
